Benomic

VALVE CHECK IN PUMP NOVEMBER 2020 VERSION: BHM202007A

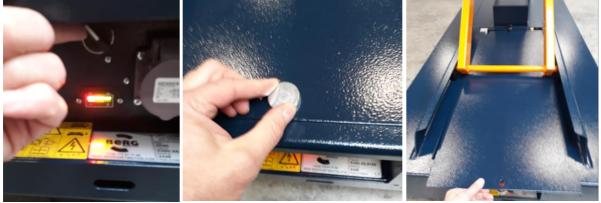
Step 1: First move the scissor up by turning the service switch, after this you can remove the cover.

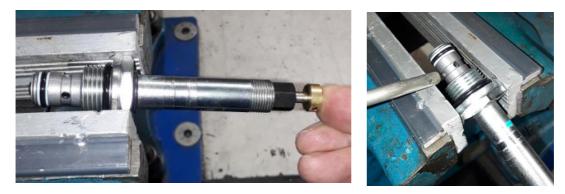
Step 6: Blow with air pressure the dirt out of the valve, push on the button so that the valve is switched open.

Please try to blow in to one of the 4 holes and block the other 3 holes with your fingers.

After this the valve should be cleaned, and can be installed again, so you can check if the problem is solved.

When the above handling have not resulted in the platform to keep its height, our advice is to repeat the procedure for at least one more time. Otherwise the valve has to be replaced by a new one. The part number is: **Scissor valve : 3030.00.0018**
