Benomic

REPLACING A DEFECTIVE GAS SPRING
JULI 2020 VERSION: BHM202007A

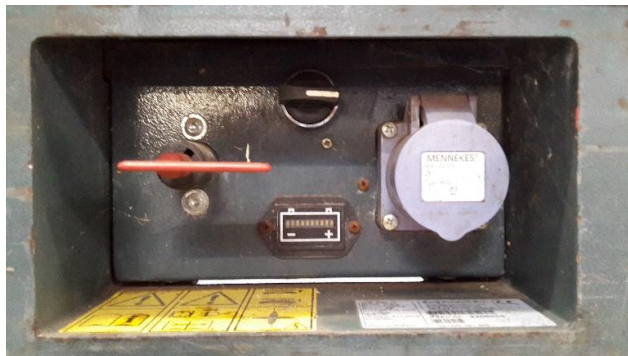
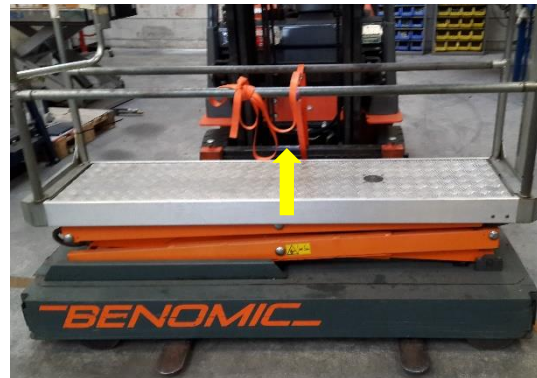
Step 1: First switch OFF and attach the Benomic to the forklift with a strap!

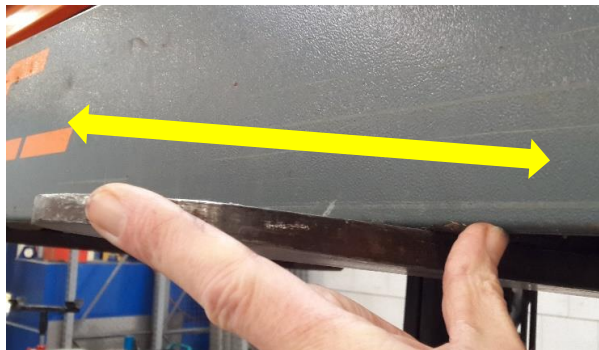
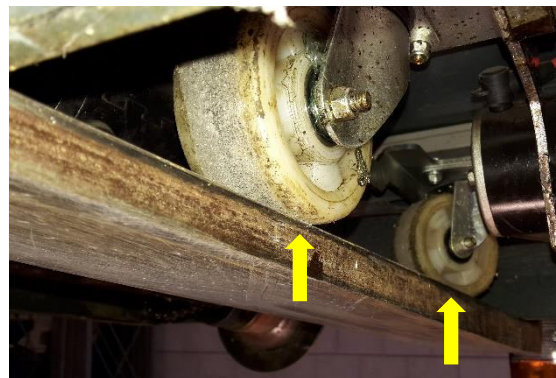
Step 2: Make sure that the forklift paddles are sufficiently crossed and lift the Benomic under the lifting wheels as shown.

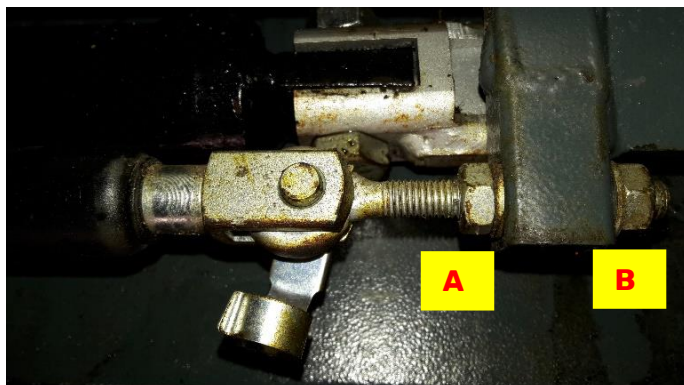
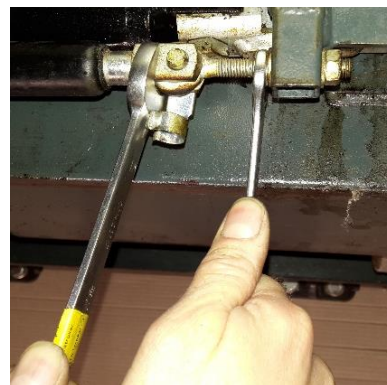
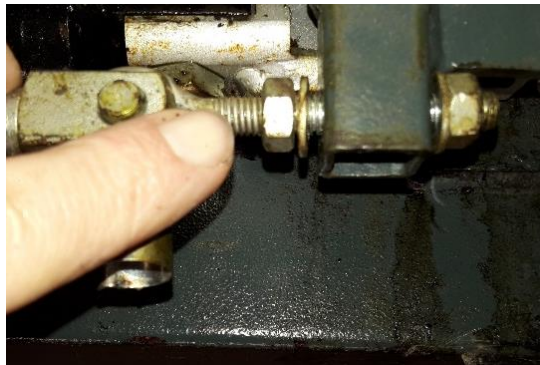
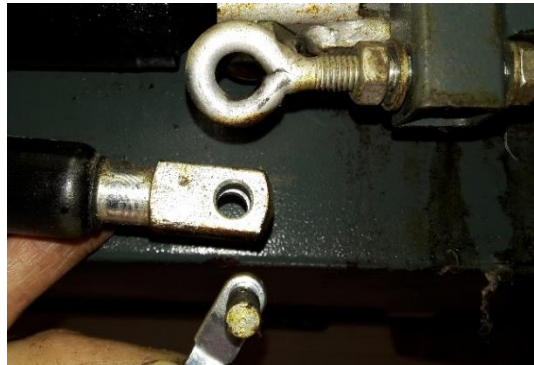
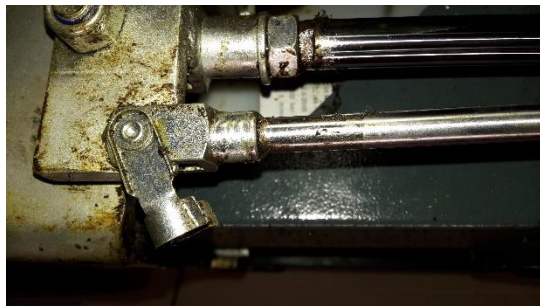
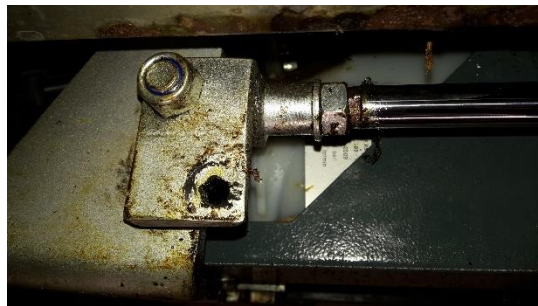
Step 3: Remove the gas spring as shown, make sure that only **nut A** is loosened, **nut B** must keep the same position!

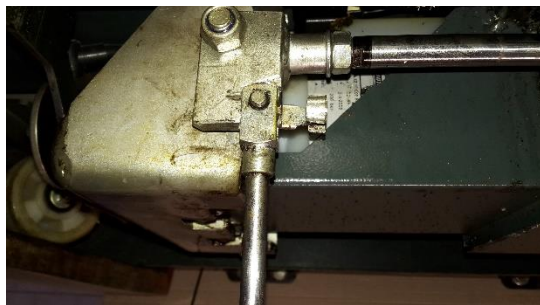
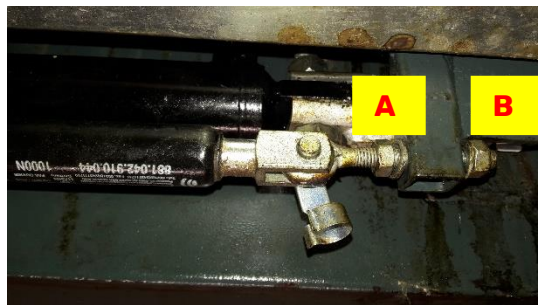
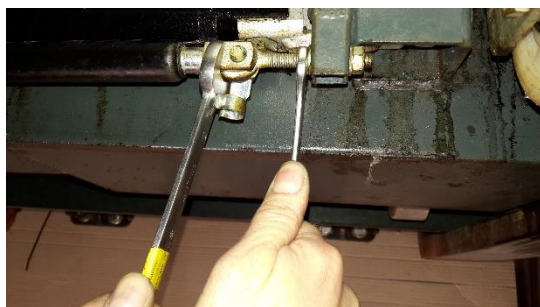
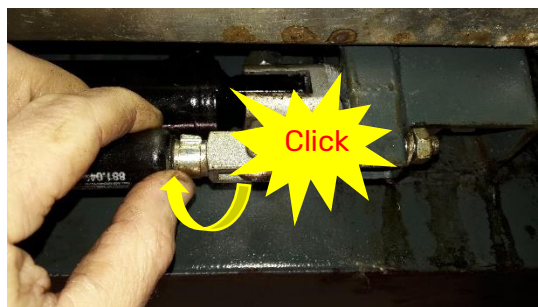
Step 4: Install the mounting bracket from the defective gas spring to the new one and mount the gas spring.
Tighten the gas spring by tightening nut A until it has no movement with respect to nut B.

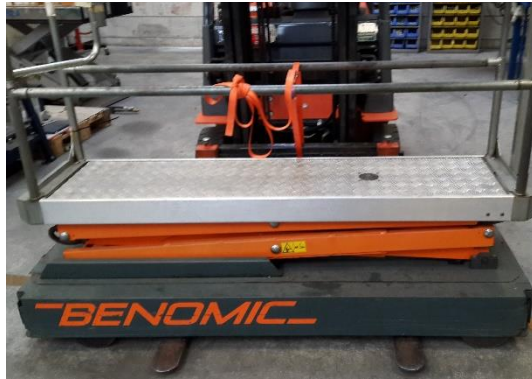
Step 5: Put the Benomic on the ground and remove the safety strap.
Check the correct working of the lifting wheel system.
